BELL
ASSOCIATES
ARCHITECTURE
PLANNING

Report No.41-11

Address of property inspected: Dundalk, Co. Louth

Dwelling: Two storey mid-terraced dwelling

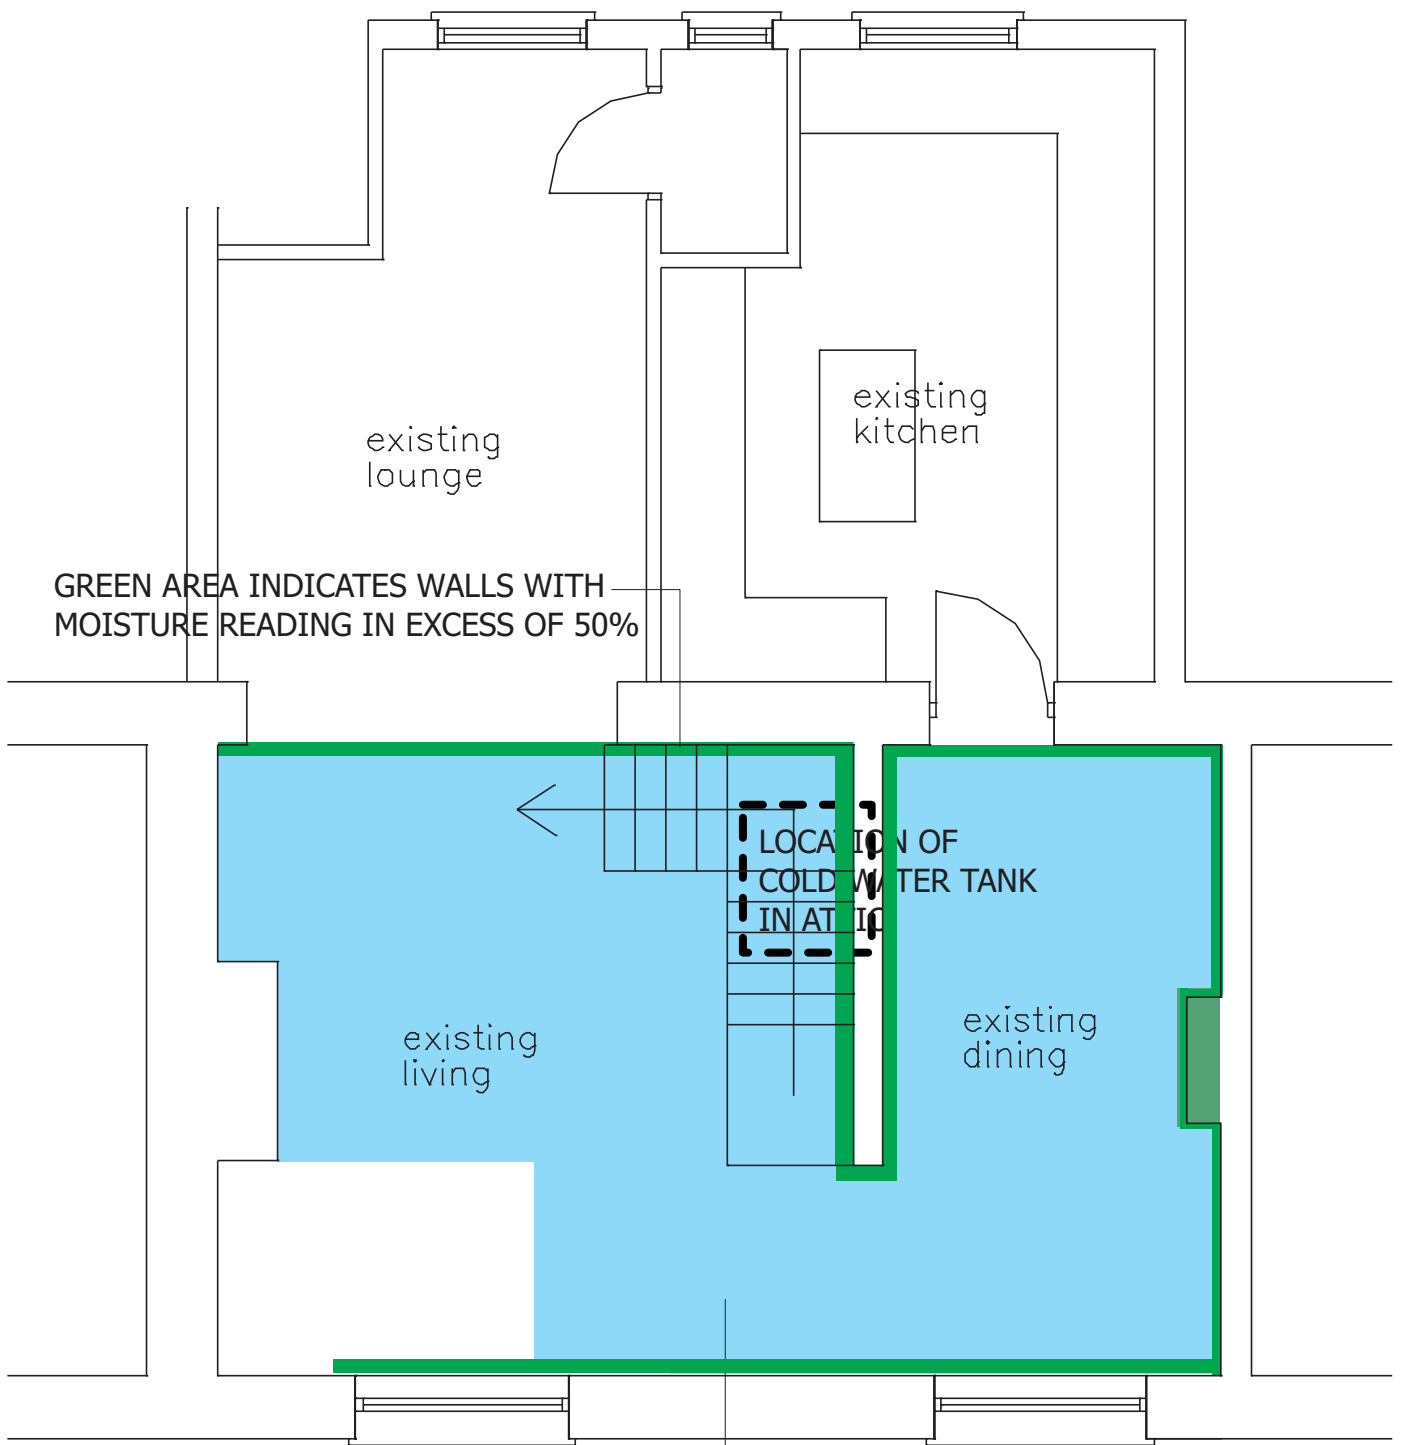
FIRST FLOOR PLAN

AREA OF FLOOR SATURATED WITH WATER INDICATED IN BLUE SEE PHOTO 8.

The first floor consists of carpet over chipboard finish, saturated areas shaded blue in the above graphic with moisture readings at 100% with water visible around footwear while walking across surface.(photo 8)

Remove carpet finishes throughout on ground and first floors.

Remove chipboard/plywood floor finishes on ground and first floors.

Re-floor all damaged areas with 22mm marine grade plywood and make good.

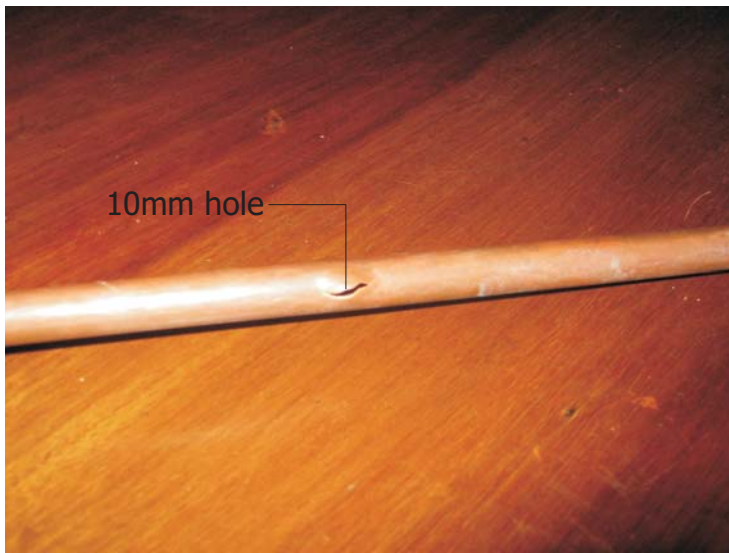
This report has been prepared to detail the damage to our clients dwelling following on from a burst rising main pipe adjacent to the cold water tank in the attic.

The mains water supply was subsequently turned off and a plumber conducted emergency remedial work by stop ending the burst pipe, and removing the damaged section of copper piping.

Photo 1 - damaged copper pipe

Re-plumb all fittings in attic area ensuring all piping, and cold water tanks suitably thermally insulated.

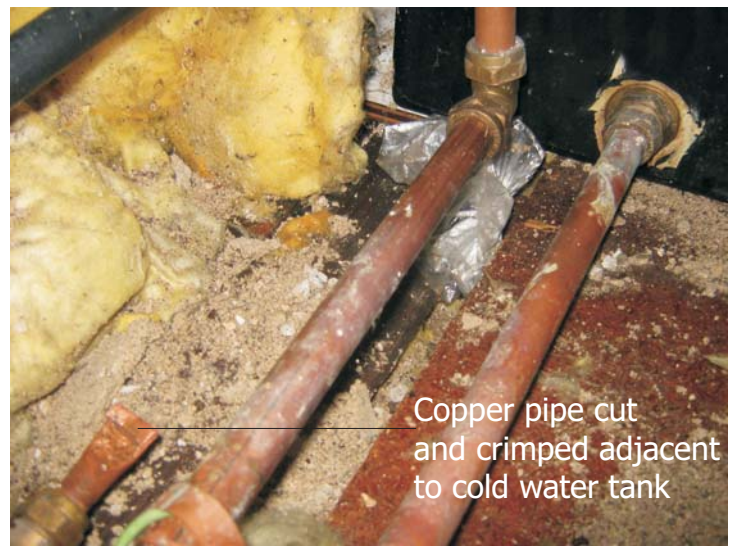
Photo 2 - copper pipe crimped

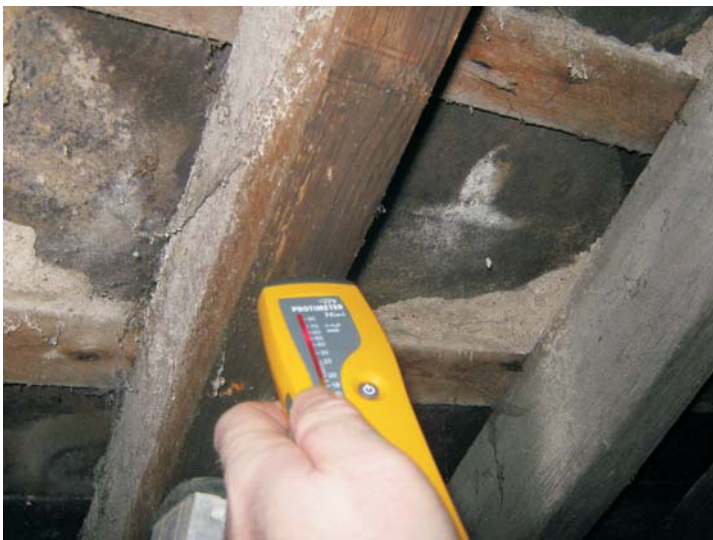
Due to the prolonged nature of the leak, the attic was sprayed with water, which saturated the rafters, joists, and the quilt insulation with readings from 35 - 100% saturation. See photos 3,4, 5 & 6 for attic moisture readings.

Photo 3 - rafter 80% moisture

Allow all surfaces to dry by natural/mechanical means.

Monitor all surfaces/materials until moisture content has dropped to acceptable levels.

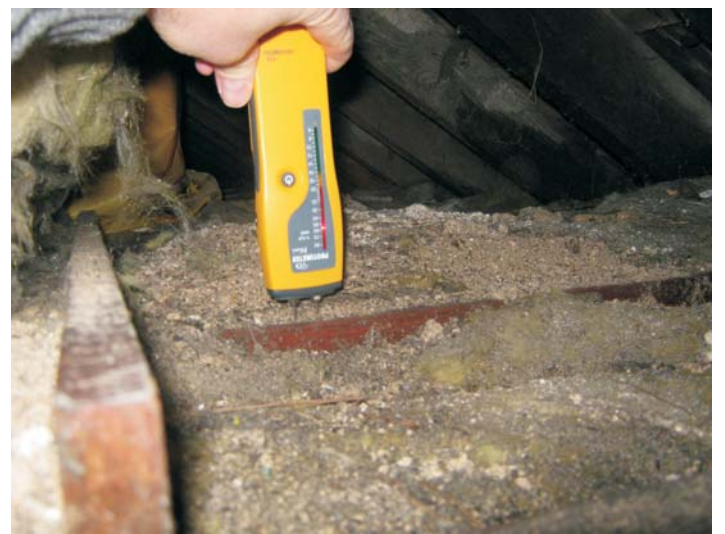
Photo 4 - joist 80% moisture

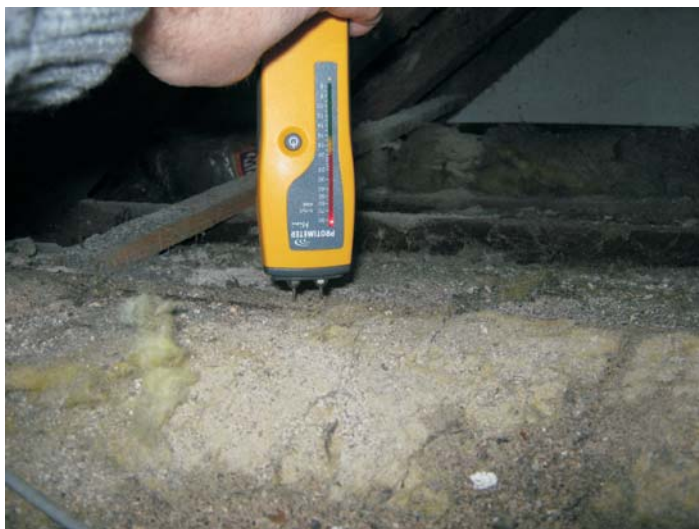
Photo 5 - joist 100% moisture

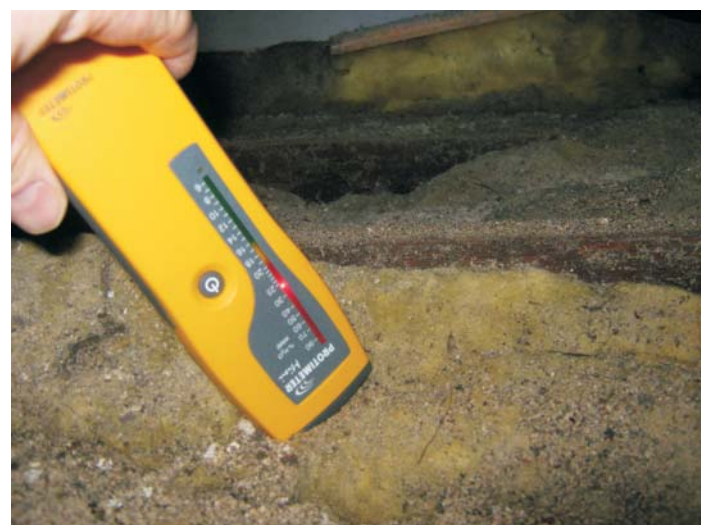
Photo 6 - insulation 35% moisture

Remove all existing quilt insulation.

Thermally insulate attic with suitable rigid board insulation.

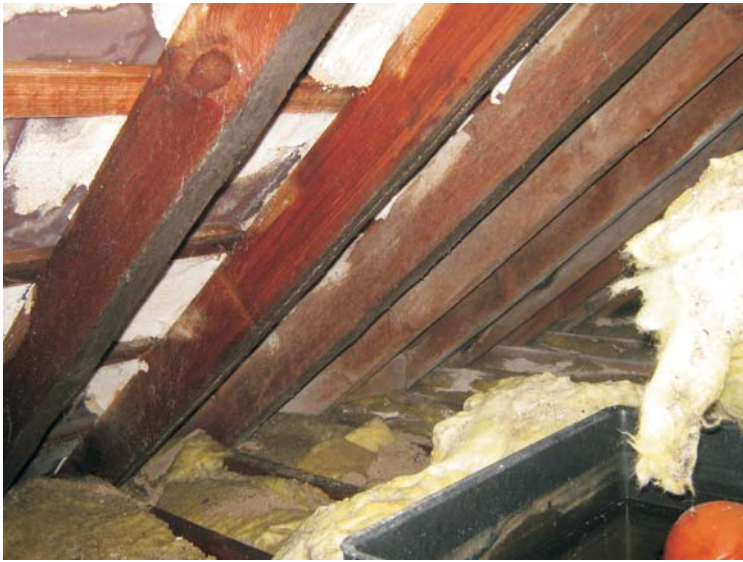
Photo 7 - saturated rafters

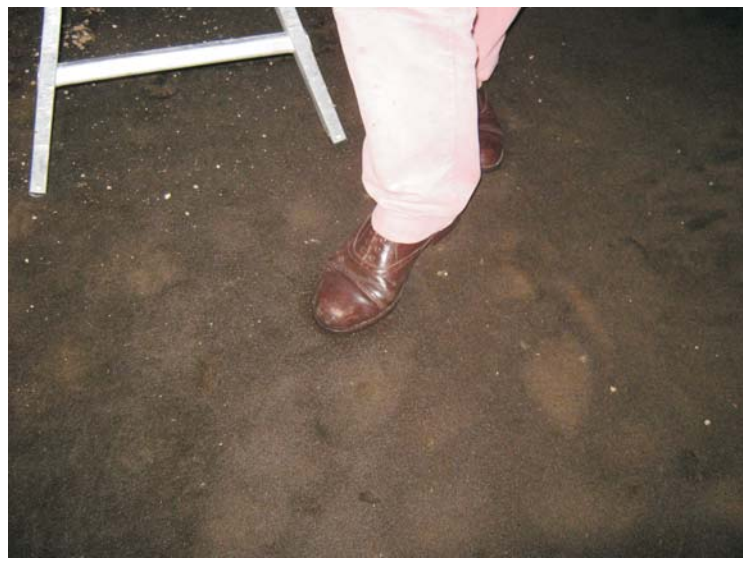
Photo 8 saturated floor/carpet

Replace all damaged floor finishes and make good.

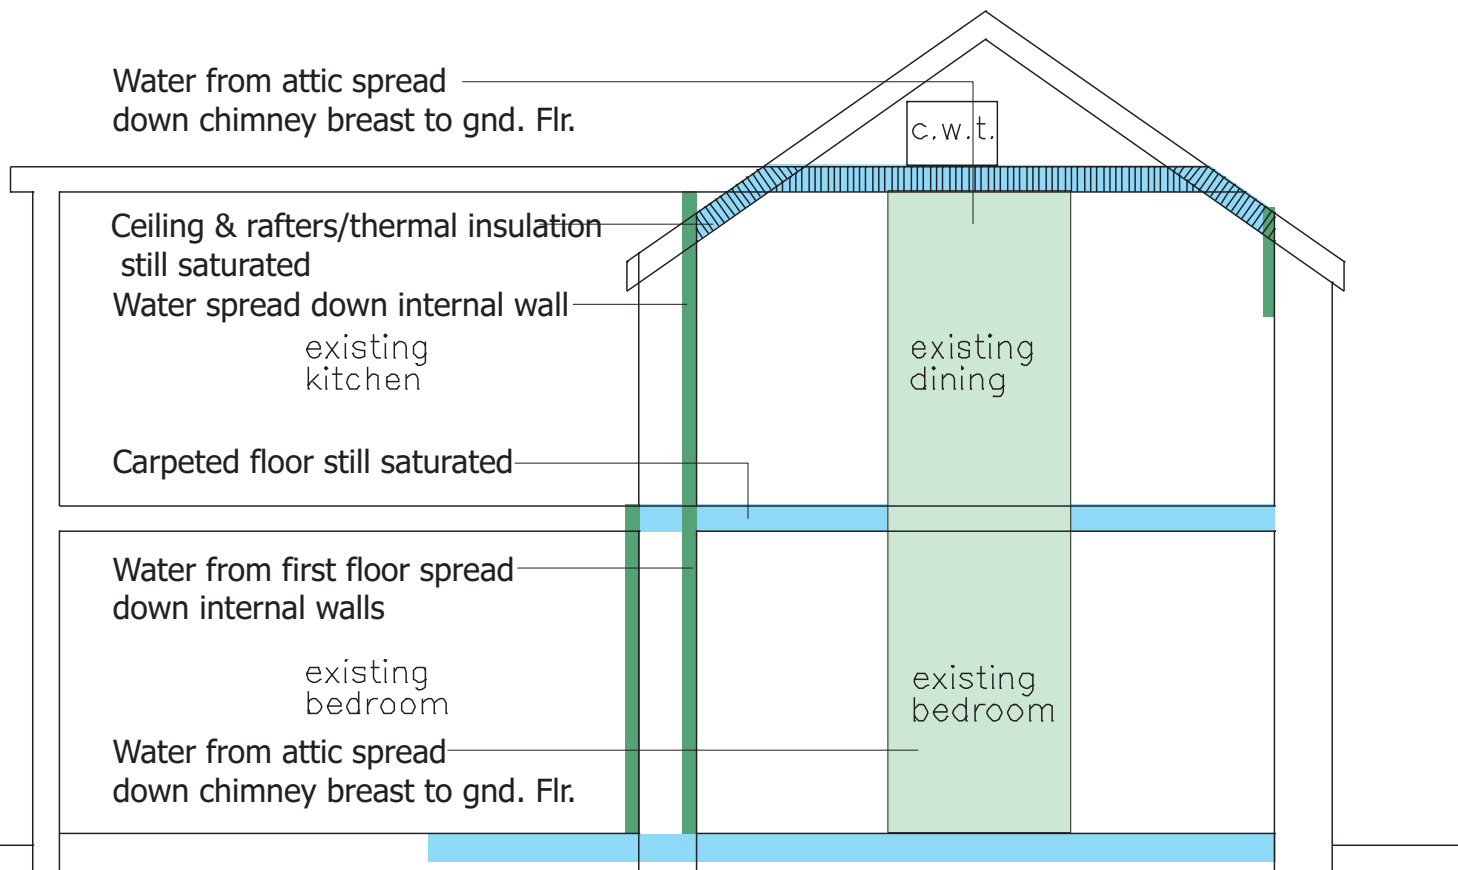
SECTION A-A

The diagram above, Section A-A shows the water spread evident on the day of survey, with water first spreading from the saturated attic dripping on to the first floor below through the ceiling. Water also spread down the chimney breast to the floor below, with moisture readings for both internal and external walls showing 40-60%.

Water spread out in to the rear of the dwelling from the first floor down the spine wall of the house with paint bubbling off the damp walls in the rear ground floor lobby, and readings in the ground floor bedrooms and the rear ground floor lobby floors showing high moisture content.

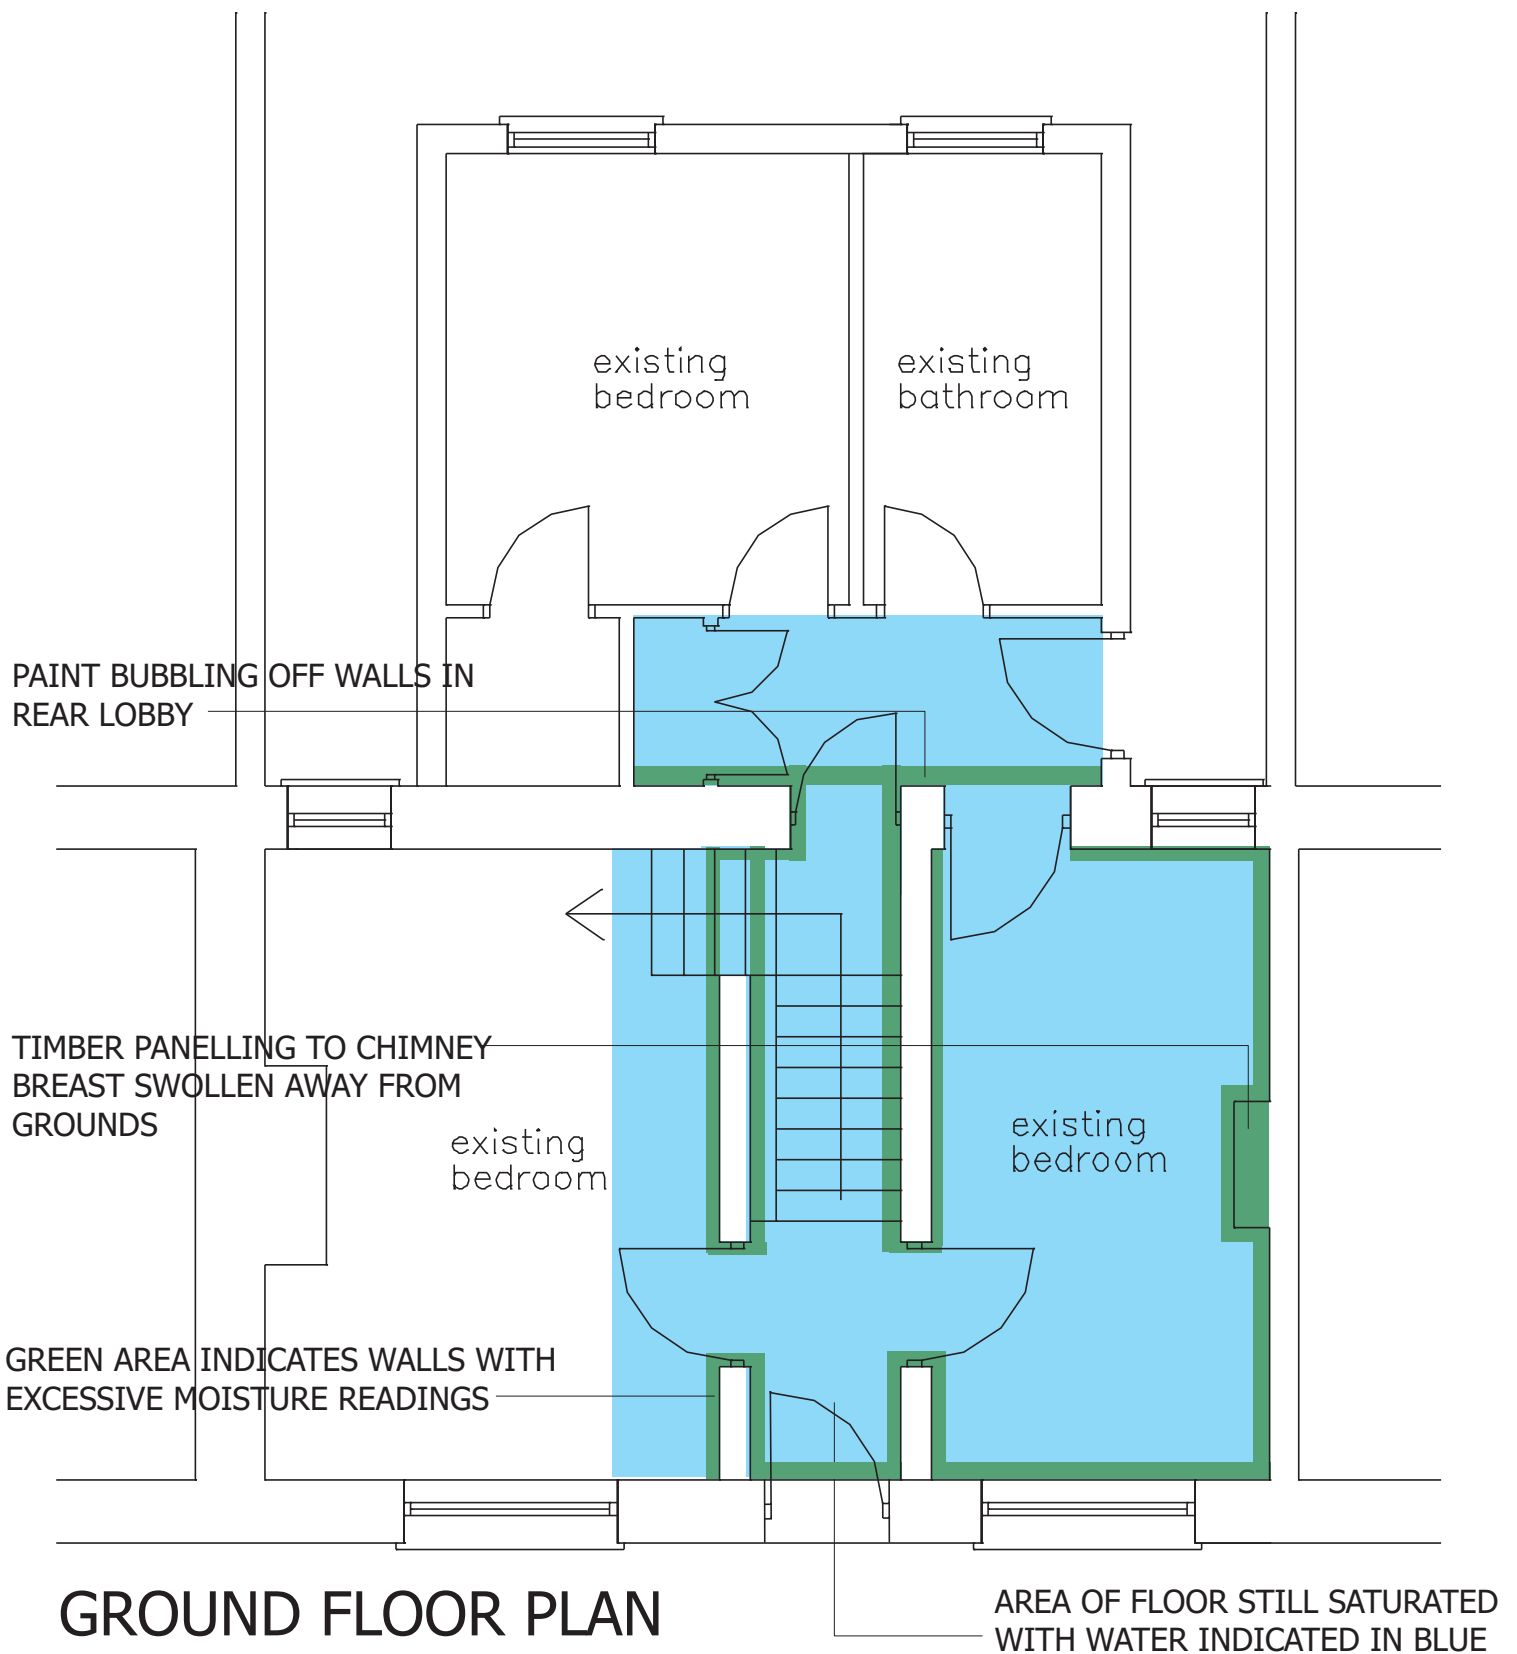
Water spread out in to the rear of the dwelling from the first floor down the spine wall of the house with paint bubbling off the damp walls in the rear ground floor lobby, and readings in the ground floor bedrooms and the rear ground floor lobby floors showing high moisture content.

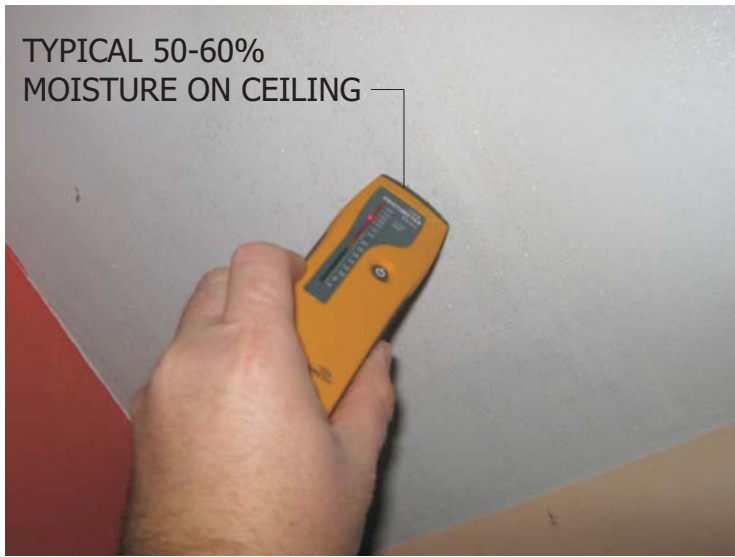
Photo 9 - typical ceiling

TYPICAL 50-60%
MOISTURE ON CEILING

Remove all existing plasterboard from first, and ground floor ceilings.

Re-slab all ceilings with suitable plasterboard/insulated bonded ceiling board, skim and make good.

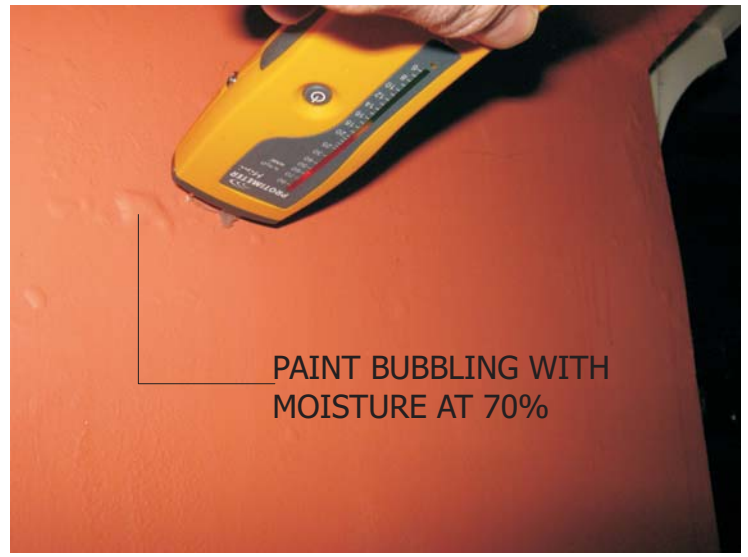
Photo 10 - typical wall

PAINT BUBBLING WITH
MOISTURE AT 70%

Examine all walls, and remove all damaged paint/plasterwork.

Assess condition of all walls and re-plaster/re-skim as appropriate and make good.

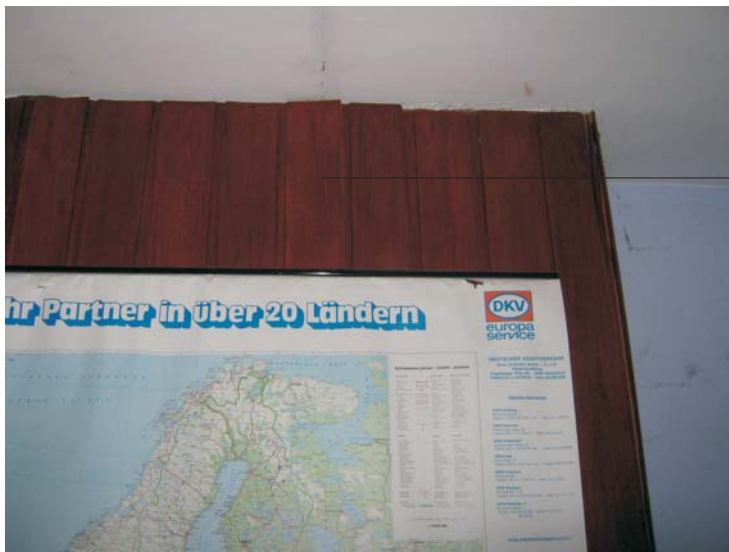
Photo 11 - chimney breast

It was also noted that timber panelling to the bedroom chimney breast was swollen and had disconnected from the grounds. Existing doors too have become swollen and are difficult to open.

SWOLLEN PANELLING
IN GROUND FLOOR
BEDROOM

Replace all skirtings, architraves and all sundry damaged joinery items, fill, sand, paint and make good.

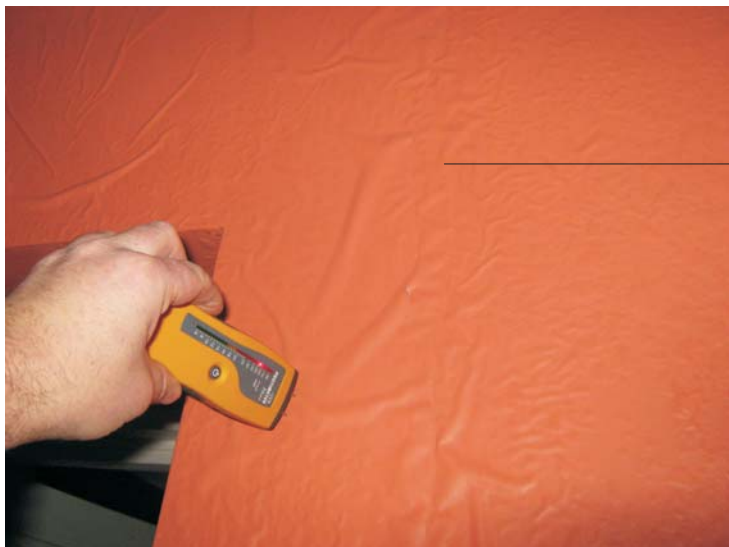
PAINT BUBBLING
FROM WALL WITH
MOISTURE AT 70%

Photo 11 - saturated wall
rear lobby - ground floor

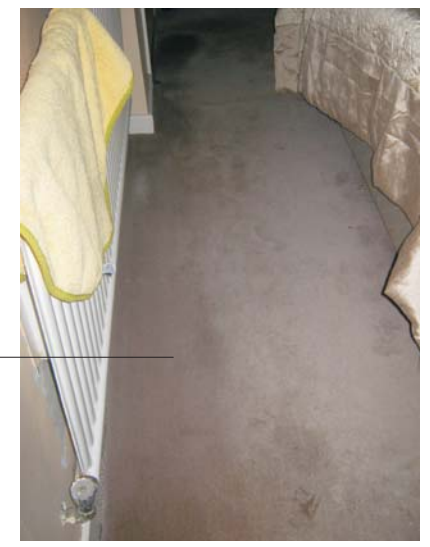
Photo 13 - ground floor bedroom

VISIBLE WATER
SATURATION ON
CARPET ON GROUND
FLOOR BEDROOM
